# ANATOMY OF AN OIL SPILL – A CASE HISTORY OF AN ONSHORE HEAVY FUEL OIL SPILL IN THE HIGHLANDS OF SCOTLAND

Based on an actual spill event, this case history was originally published in the Oil Spill Bulletin and Environmental Review (OSBER), a monthly journal published by Alba International Ltd., based in Aberdeen, Scotland. It was reprinted in the ISCO Newsletter during June 2012. One ISCO member, Brian O'Connor, of the Canberra and Regions Oil Industry Response Group in Australia found the article so useful that he had it reprinted as a booklet for training purposes.

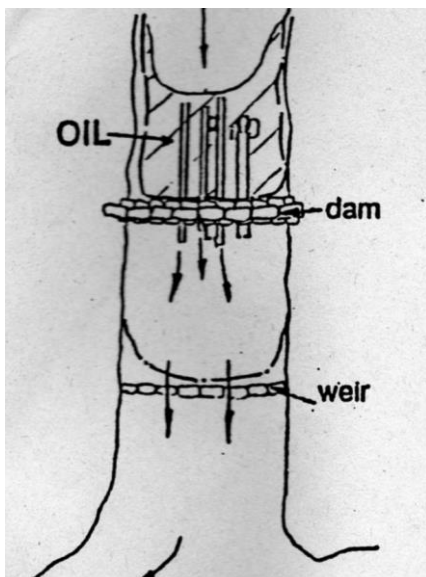
The story so far - A leak of heavy oil from an industrial plant in the Scottish Highlands has resulted in pollution of a local burn, a larger stream / minor river and the main river into which it runs.

A pollution response company has been called out and the spill has been contained both at source and where the stream flows into the river. The next phases, RECOVERY and CLEAN-UP are about to begin.

*In this sketch, the underpass dam illustrated is a pipeline underpass rather than a bridge type underpass dam, but the principle of operation is the same.*

After a somewhat stormy journey over the hills, the pollution control company's vehicles and personnel have arrived on site. The first priority is to contain the spill completely. After a site survey, it is decided to build a sandbag dam and weir (interceptor dam) down at the mouth of the smaller river, and a smaller one at the mouth of the drain. The dams will have underpasses to allow water to flow through underneath, and the water levels will be kept above the levels of the underpasses by means of the weir barriers constructed immediately downstream of each dam. This way, the oil will be trapped behind the underpass dams but the water can flow freely. The underpass dams are constructed by building sandbag piers which are then bridged over with strong wooden planks, on top of which more sandbags are placed to create a low wall that will retain the oil<sup>1</sup>. The downstream weir, also constructed with sandbags<sup>2</sup>, has the effect of locally raising the water level thus ensuring that the oil is held behind the underpass dams<sup>3</sup>. With the rise in water level due to the rain, oil has been carried up the banks in both the burn and the small river. The main river's level has risen slightly.

<sup>1</sup> An alternative to building a bridge type underpass dam is to use a few lengths of large diameter pipe to enable water to flow through. Pipes should be installed in the sandbag wall a little above the bottom of the watercourse. The number/size of pipes used must be enough to provide a sufficient safety margin to allow unobstructed flow of water even in spate conditions otherwise water will back up, the level will rise and trapped oil will be lost over the top of the underpass dam. The bridge type underpass dam requires fewer sandbags and can be constructed more quickly than an underpass dam using pipes.

<sup>2</sup> It is recommended that heavy duty plastic sheeting be used to line the inner side of the weir dam and arranged to drape over the top of the dam. This protects the top of the weir dam from erosion caused by water flow over an extended period of time. Plastic sheeting can also be used to help to ensure that the upper part of the underpass dam makes an oil tight seal.

<sup>3</sup> The height of the weir dam needs to be such that the underpass dam has sufficient freeboard to retain trapped oil.

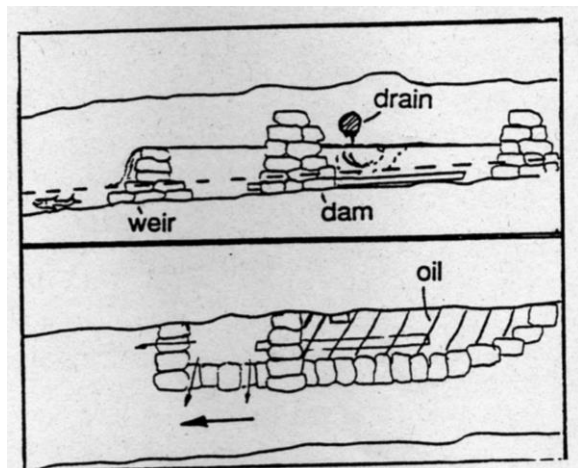
The story so far – A leak of heavy oil from an industrial plant in the Scottish Highlands has resulted in major pollution of a local burn, a larger stream and some minor pollution of the river into which they flow. A pollution response company has been called out, and the CONTAINMENT phase has been completed. The RECOVERY and CLEAN-UP work is continuing.

*This sketch shows a "mini" interceptor dam that can be built to catch and retain oil entering a watercourse via a water drain. The advantage is that an oily drain can be decontaminated (flushing or cleaning with a high pressure retrojet) without risk of oil entering the watercourse.*

Oil has also been collecting in the "mini" interceptor dam where the factory drain exits into the small burn. Here, the amount of oil is not large and can be manually scooped into open top drums.

The vacuum tanker returns and commences by emptying the portable holding tank at the underpass dam. Open top barrels used for holding recovered oil at the "mini" interceptor where the factory drainage system exits to the small burn also have to be emptied.
