## CASE HISTORY: “PORECHYE – EMPTY TANKS” APPLICATION OF “HOT TAP” TECHNIQUE

*This article originally appeared in the January 1994 issue of The OSBER, a monthly magazine published by Alba International Ltd. The story is about an event that could have taken place yesterday and the lessons learned remain relevant to this day.*

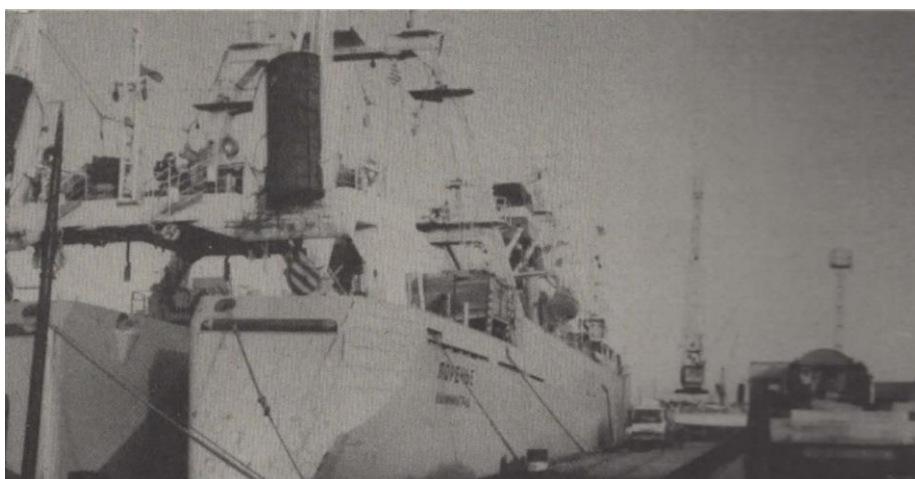
January started quietly, unlike last year, when the “Braer”<sup>1</sup> sent us into overdrive. On Tuesday a telephone call from Tyne Dock Engineering, South Shields, put the team into gear again. The klondyker<sup>2</sup> “Porechye” had hit the rocks and damaged her hull and portside fuel tanks. At this time she was lying off the mouth of the Tyne and traces of oil from damaged tanks were observed. A survey by divers was carried out to estimate the amount of oil being lost and the extent of the damage

*Picture: Porechye before going into dry dock*

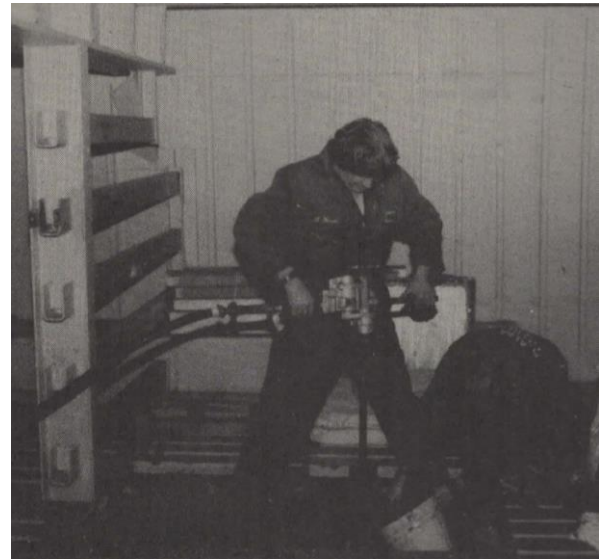
*Picture: Hot-tapping – The only available access route via manifold*

Although this sounds quite simple, unfortunately it is not. Tank tops are not always where you can get to them and, on this occasion, one of the tanks fell into this category. The tank in question lay under another tank which still contained an estimated 300 tons of fuel.

The only available access route was via a tank overflow manifold, located in the forward air conditioning machinery room. This was achieved and over the next 12 hours marine fuel oil (MFO) was removed at a steady rate and transferred around the ship. In total 140 tons of MFO was transferred from **"the empty tanks"**.

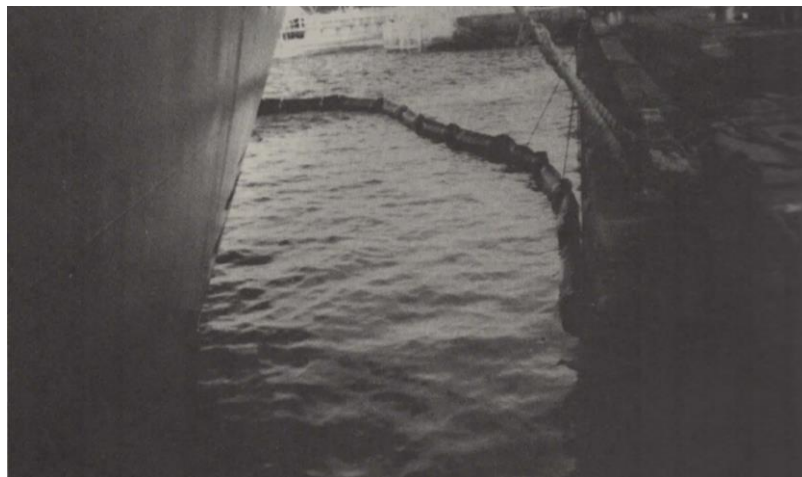
*Picture: Deployment of boom to contain possible spill*

Because of the need to hold the ship in berth to await the next docking opportunity the Tyne Harbourmaster required that a precautionary containment boom be deployed around the vessel.

It was decided to use 200 m. of Bay Ro-Boom and this proved to be ideal for the purpose. The deployment complete, the team headed back to Aberdeen, leaving one man to attend the boom.
