# ANATOMY OF AN OIL SPILL – A CASE HISTORY OF AN ONSHORE HEAVY FUEL OIL SPILL IN THE HIGHLANDS OF SCOTLAND

Based on an actual spill event, this case history was originally published in the Oil Spill Bulletin and Environmental Review (OSBER), a monthly journal published by Alba International Ltd., based in Aberdeen, Scotland. It was reprinted in the ISCO Newsletter during June 2012. One ISCO member, Brian O'Connor, of the Canberra and Regions Oil Industry Response Group in Australia found the article so useful that he had it reprinted as a booklet for training purposes.

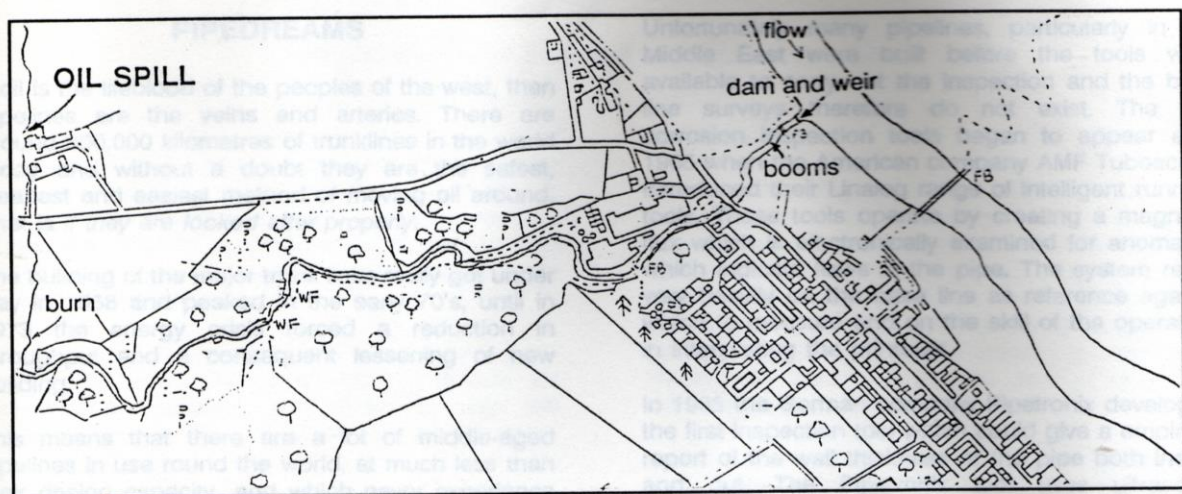
At an industrial site in a remote glen the night watchman completes his rounds. All appears well. Unknown to him a faulty weld in an old section of pipe carrying heavy heating oil from a storage tank is giving way even as he fills in his logbook.

Because it's the weekend no one is around and the spill has gone unnoticed. The oil has been spreading across a concrete yard for six hours. It is already finding its way into the surface water drainage system. There are no interceptors fitted.
